Alarm code	9F	DHW Thermistor(TDHW) abnormality

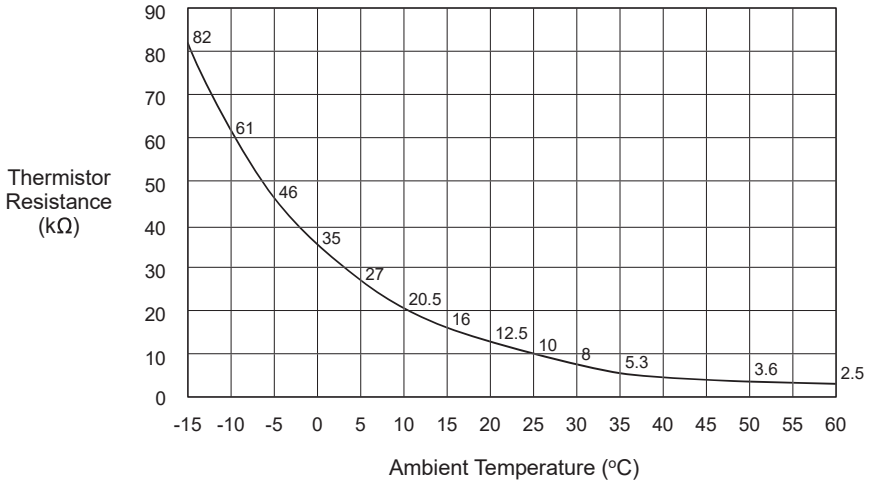
Thermistor Characteristics

- Alarm code is displayed on the master controller/ the 7-segment of O.U. display PCB / the 7-segment of I.U. PCB1.
- This alarm code is indicated when a short circuit (less than 0.24kΩ) or disconnection (more than 840kΩ) of the thermistor is detected during the heating or cooling operation. The operation is automatically restarted when the malfunction is removed.
- Reset the unit to release the alarm.
